Manhole Inspection Summary

Manhole # S17E1_010MH

Insp Date: **5/14/08 2:14 PM**

Location Address: **2830 maudin av**

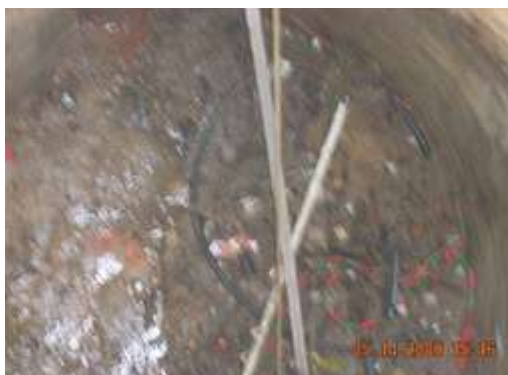
Defect 5

Condition: ☐ Sound ☐ Cracked ☐ Root Intrusion ☐ Deteriorated ☐ Leaks ☒ **Debris**

debris in terminal channel

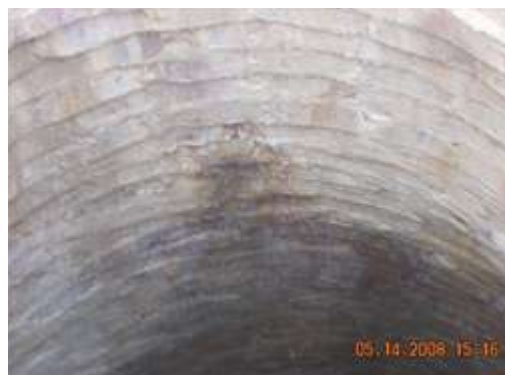
Defect 4

Infiltration: ☐ None ☐ Joint ☐ Cracks ☐ Mortar ☐ Roots ☒ **Wall**

infiltration @ barrel wall

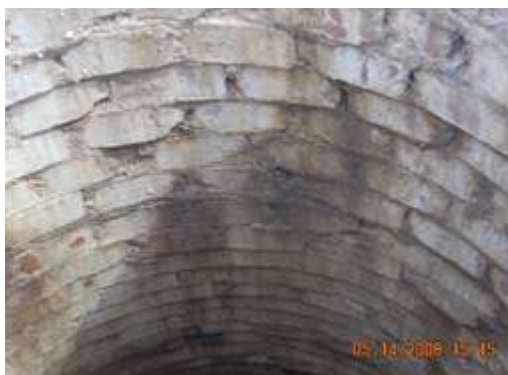
Defect 3

Infiltration: ☐ None ☐ Joint ☐ Cracks ☐ Mortar ☐ Roots ☒ **Wall**

infiltration @ corbel wall

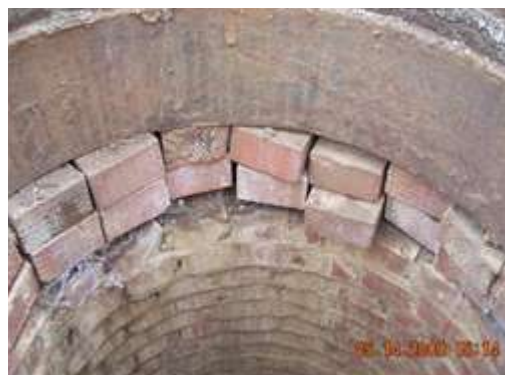
Defect 2

Condition: ☐ Sound ☐ Cracked ☐ Root Intrusion ☒ **Loose Brick** ☐ Deteriorated

loose chimney bricks

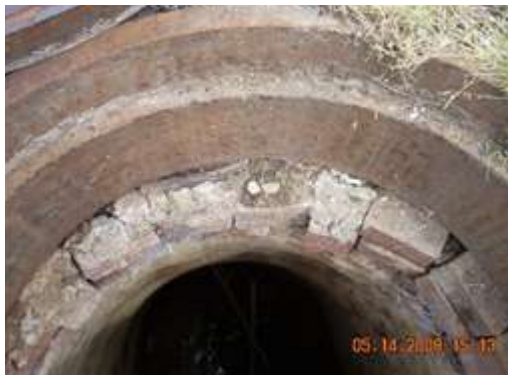
Defect 1

Offset: **2** (in.)

frame offset

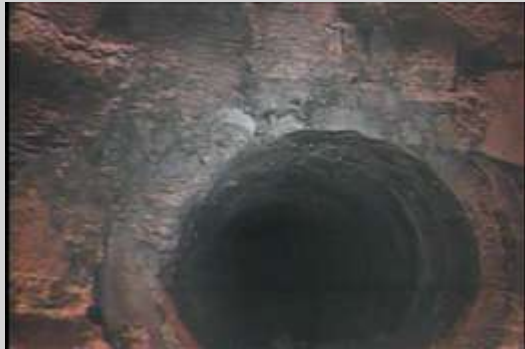
12 O'Clock Outflow

Deposits: ☐ None ☒ **Mud** ☐ Sludge ☐ Debris ☐ Grease

Silt Depth: **1** (in.) Deposits Extent: **Light**

Infiltration: **None** Pipe Seal Cond: **Cracked**
